Contract #: 04-0120F4Cty: SF/ALA Rte: 80 PM: 13.2/13.9File #: 1.28**WELDING INSPECTION REPORT****Resident Engineer:** Pursell, Gary**Address:** 333 Burma Road**City:** Oakland, CA 94607**Report No:** WIR-013568**Date Inspected:** 30-Apr-2010**Project Name:** SAS Superstructure**OSM Arrival Time:** 730**Prime Contractor:** American Bridge/Fluor Enterprises, a JV**OSM Departure Time:** 1600**Contractor:** American Bridge/Fluor Enterprises, a JV**Location:** Job Site**CWI Name:** James Cunningham**CWI Present:** Yes No**Inspected CWI report:** Yes No N/A**Rod Oven in Use:** Yes No N/A**Electrode to specification:** Yes No N/A**Weld Procedures Followed:** Yes No N/A**Qualified Welders:** Yes No N/A**Verified Joint Fit-up:** Yes No N/A**Approved Drawings:** Yes No N/A**Approved WPS:** Yes No N/A**Delayed / Cancelled:** Yes No N/A**Bridge No:** 34-0006**Component:** Orthotropic Box Girders**Summary of Items Observed:**

WELDING INSPECTION REPORT

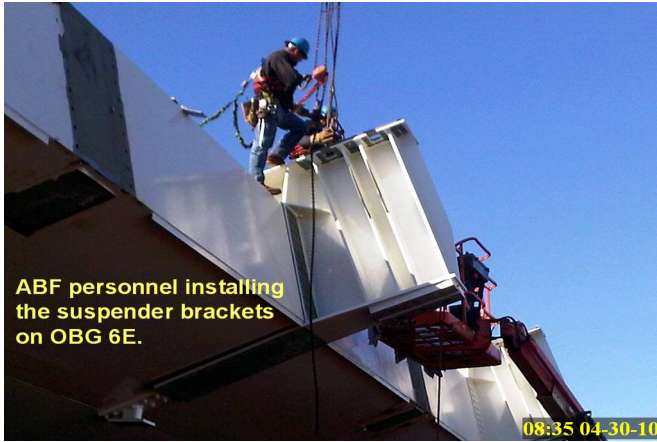
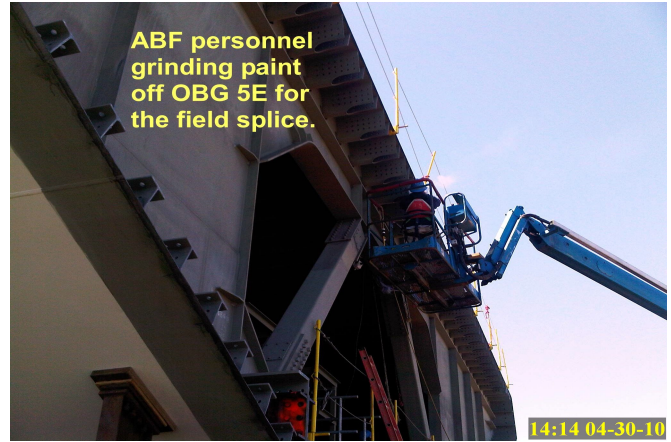
The QAI observed ABF activities at the Pier 7 location. The QAI noted that the Quality Control (QC) Inspector James Cunningham is present. The QAI inquired with the QC Inspector if there would be any welding today. The QAI was informed that there was no welding planned. The QAI noted that at this time, the shims on OBG segments 5E and 6E have been tack welded onto the bottom plate at the crossbeam intersections. The QAI observed ABF personnel cutting the access holes through the top deck of OBG segment 5E. The QAI observed ABF personnel installing the remaining suspender brackets onto OBG segment 6E with loose fit temporary bolts. The QAI observed other ABF personnel setting grating, lights, ventilation parts, electrical and compressed air utilities into the OBG segments. The QAI noted that these are temporary utilities and will be used during the fabrication of the SAS. The QAI also observed ABF personnel using aerial lifts to access the OBG plate edges and were visibly grinding the primer paint and bevel faces in preparation for the field splice welding. The QAI noted that the deck plate thickness transitions, where visible from the barge decks, appear to be unmodified from the as received condition with an apparent 1/2.5 taper. The QAI attempted to ask the QC Inspector if he was aware of the directions that ABF's Welding Quality Control Manager Jim Bowers had announced earlier this week, that the transitions would be ground to a more shallow taper for the ease of joint and backing bar fit-up during the field splicing operations. The QC Inspector did not make himself available for this question. The QAI noted that this work was in progress until the end of the shift. See the attached photos.
